# Durability of post-tensioning tendons

Workshop 15-16 November 2001  
Ghent (Belgium)

Technical report

**Proceedings of a workshop held at  
Ghent University on 15-16 November 2001**

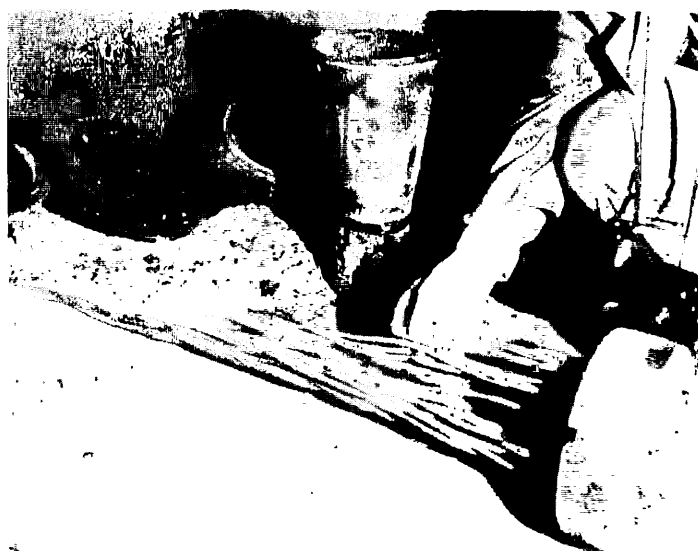
*Fig. 6: Rupture of the tendon in the form of a bevel near its anchoring head.*

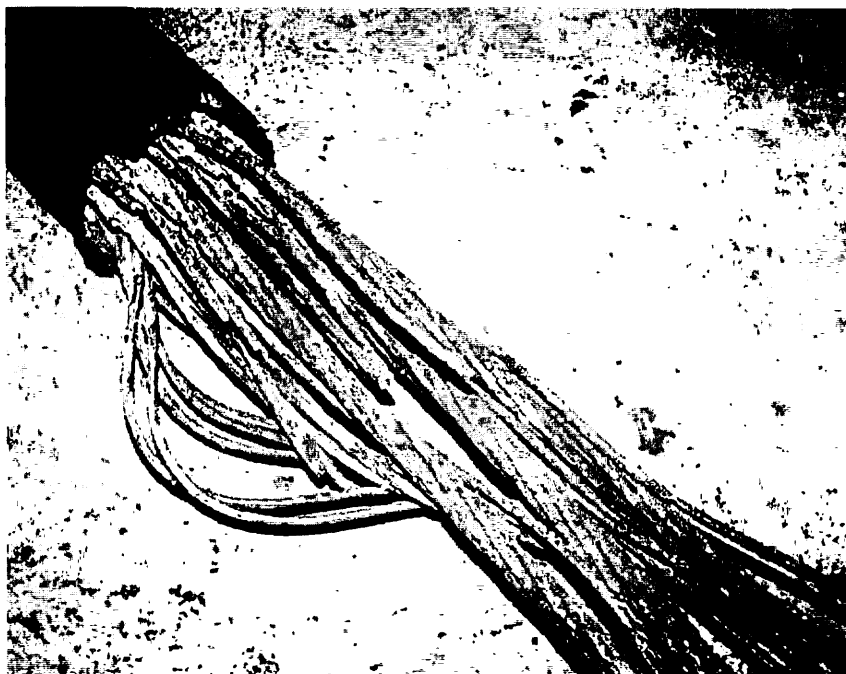
*Fig. 8: Corrosion and broken wires in the failure zone.*

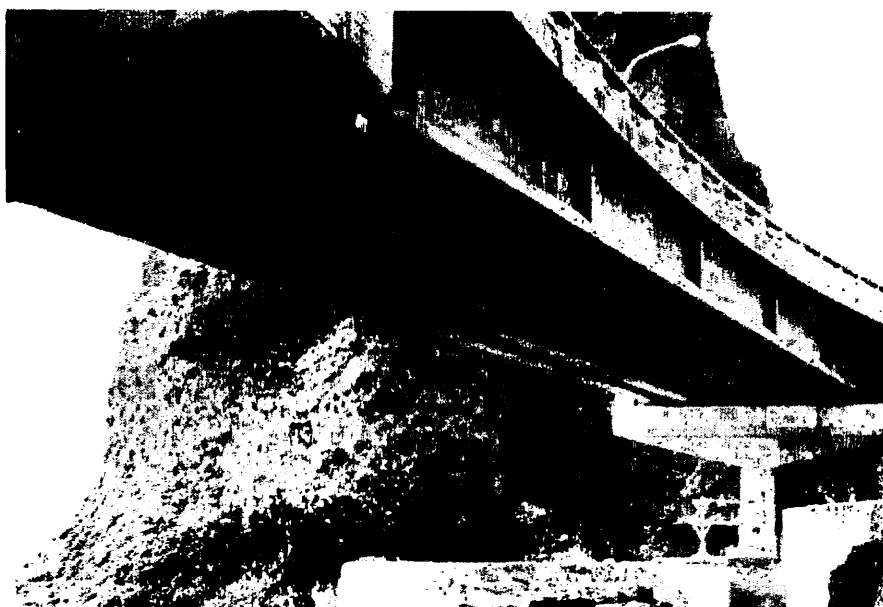
*Fig. 14: Rust and damage in girders of Kuretsubo Bridge [1]*

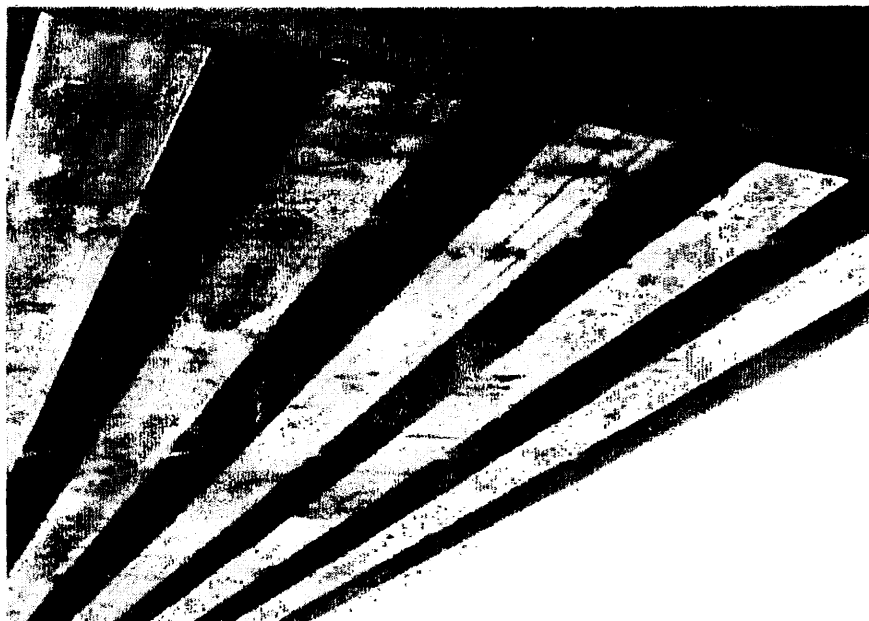
*Fig. 15: Rust and damage in girders of Kuretsubo Bridge [1]*

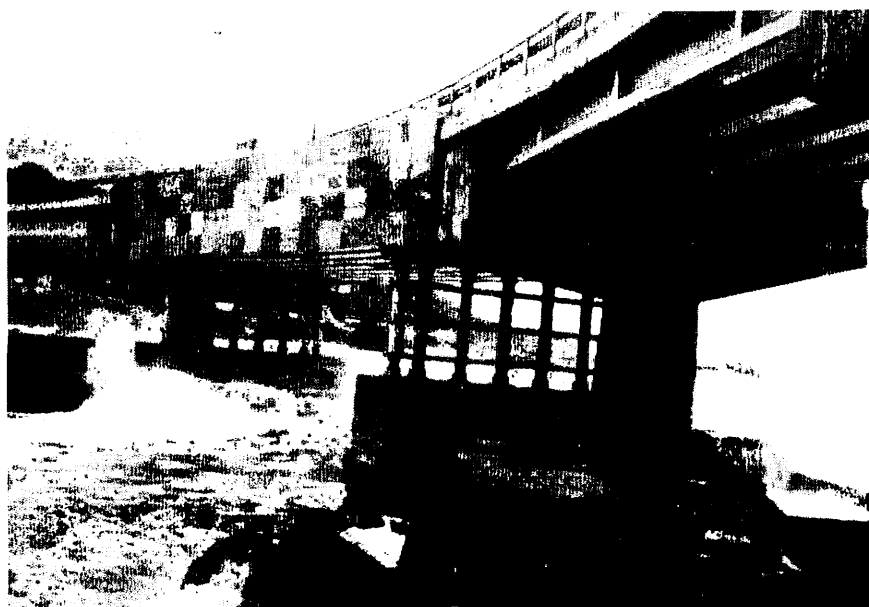
*Fig. 16: Construction of additional supports in Kuretsubo Bridge [1]*

strengthened by external post-tensioning and additional piers were built between the existing piers to reduce the working stress in the girders (Fig. 16). Fig. 17 shows the breaking of prestressing cables. This old PC bridge was reconstructed recently changing design details such as increase of cover concrete, use of epoxy-coated steel bars and prestressing *tendons* and use of polyethylene sheaths. Learning lessons from terrible deterioration of this particular bridge, many PC bridges were investigated in Japan for contents of chloride ion in concrete, cover of reinforcements and distance of bridge from the nearest coastline.

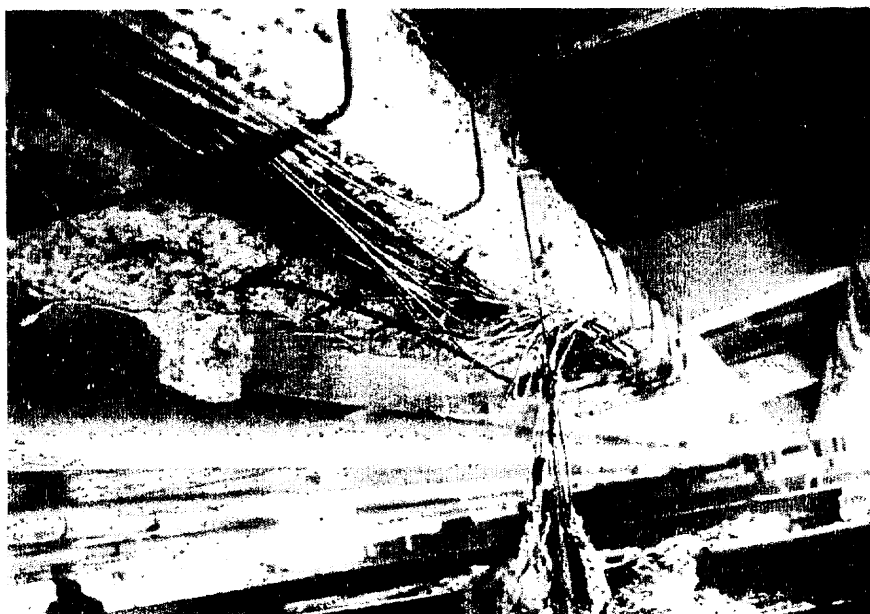
Fig. 17: Breaking of prestressing tendons in Kuretsubo Bridge [1]

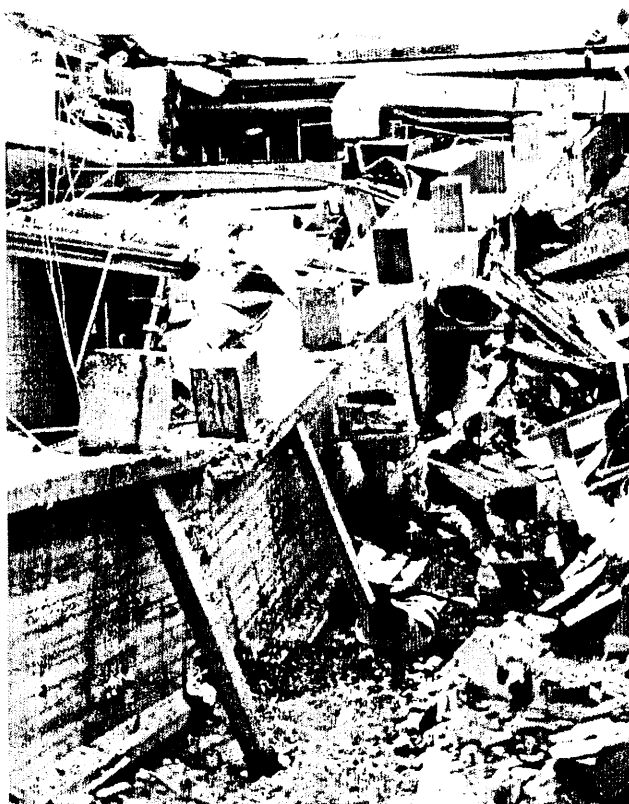
*Fig. 3: Broken beam as a result of stress corrosion cracking*

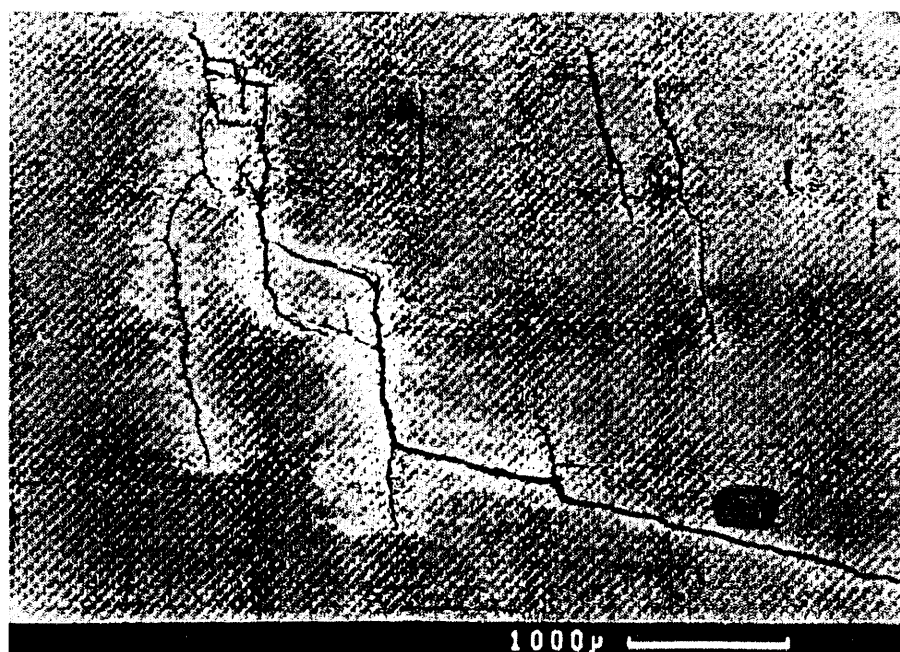
*Fig. 7: Cracking of the cold deformed wires*

In this case the prestressing steel proved to be extremely sensitive to hydrogen influence. The strength of the steel was higher than 2000 N/mm<sup>2</sup> and as a result of radial shear stresses firstly longitudinal and later also transverse cracking took place (Fig. 7).
